2005 Monitoring Summary

Channahatchee Creek at Elmore County Road 357 near Eclectic (32.65024/-85.95085)

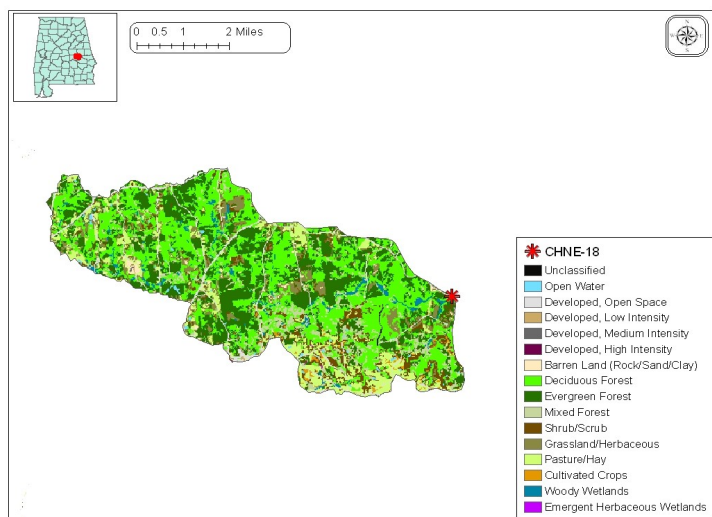
Figure 1. Watershed characteristics of Channahatchee Creek at CHNE-18.

Watershed characteristics are summarized in Table 1. The Channahatchee Creek watershed at CHNE-18 is located in the Tallapoosa River basin. It is composed primarily of forest (69%), grasslands, and some pasture (Fig. 1). Population estimate was relatively high in this watershed. Some permitted discharges also existed.
